## University Improves Sustainability of HVAC Motors in Platinum LEED® Building

### Overview

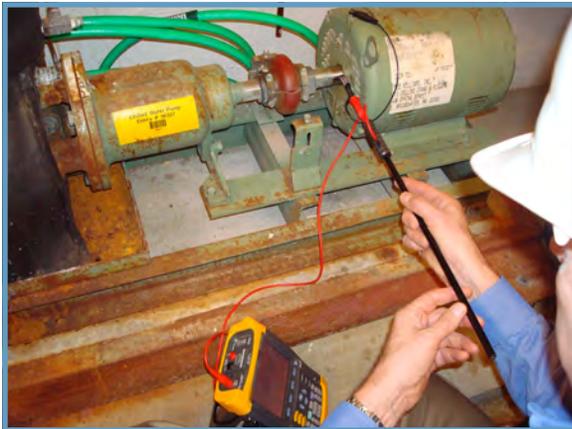
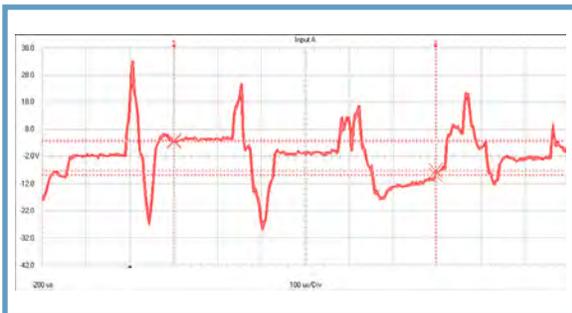
Before the grounding ring was installed on Motor #1, the shaft guard was removed. With the VFD set at 60 Hz, the motor was running at 1,776 rpm (7.2 amperes). When a voltage probe was held against the motor shaft, the oscilloscope (set at 10 volts and 100 microseconds per division) indicated peak-to-peak discharges of 61 volts. The oscilloscope display showed rapid voltage collapses at the trailing edge of the waveform — typical of the electrical discharges that damage bearings.

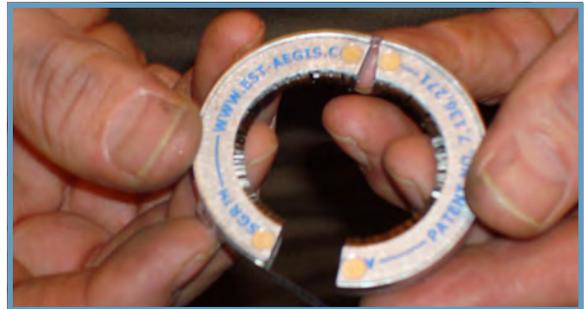
After the readings, the shaft was cleaned with fine-grit sandpaper and wiped off with an alcohol-dampened rag. Paint was removed from the motor end bracket with a Dremel rotary tool and small wire-brush bit to expose a bare metal surface against which the grounding ring would be mounted with conductive epoxy. In addition to the split-ring AEGIS® SGR, the manufacturer's kit contained tubes of conductive epoxy and activator. The tape was then removed from one joint of the ring, allowing it to be opened, to fit over the motor's shaft without the need to de-couple and realign the motor to the pump.

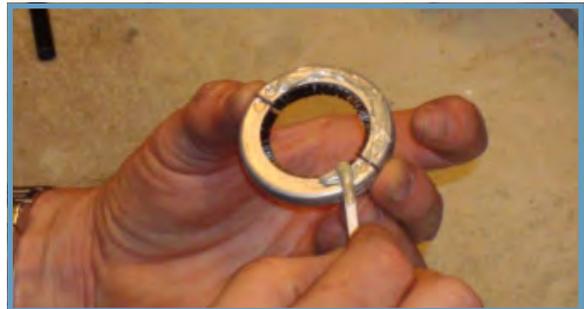
Equal proportions of epoxy and activator were then mixed, and small amounts were applied to the back of the ring.

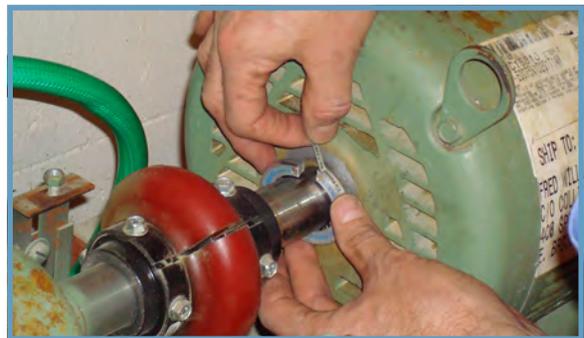
Prior to installing the ring, a narrow band of AEGIS® colloidal silver coating was applied around the shaft where the fibers contact it, to improve the surface conductivity. The ring was then installed on the shaft and re-taped.

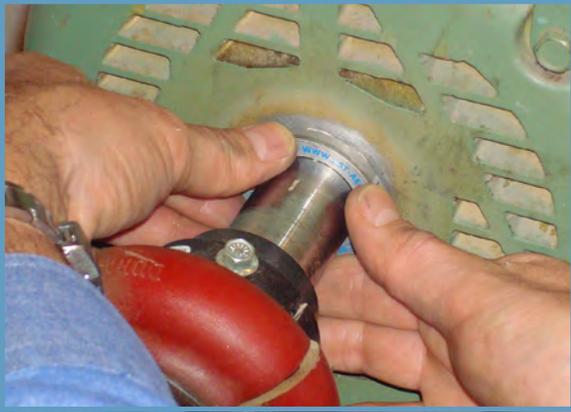
Next, the ring was pushed back against the bare metal of the end bracket, maximizing electrical contact via the conductive epoxy. To ensure that the ring was correctly centered around the shaft, small metal spacers (included in the kit) were inserted into the gaps between the two halves of the ring. Once the adhesive cured, the spacers were removed. The entire installation took about 10 minutes.

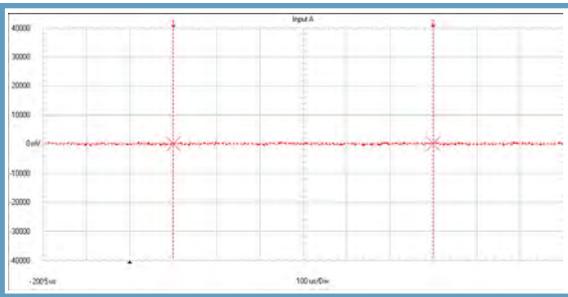
Approximately an hour after installation, the epoxy had cured sufficiently to allow testing of the motor again with the oscilloscope and probe. This time, with the VFD set at 60 Hz, the motor running at 1,775 rpm (7.4 amperes), and the oscilloscope set at 10 millivolts and 100 microseconds per division, the discharge plot displayed on the scope was essentially a straight line, indicating that shaft voltage discharges were being diverted by the AEGIS® ring to ground.

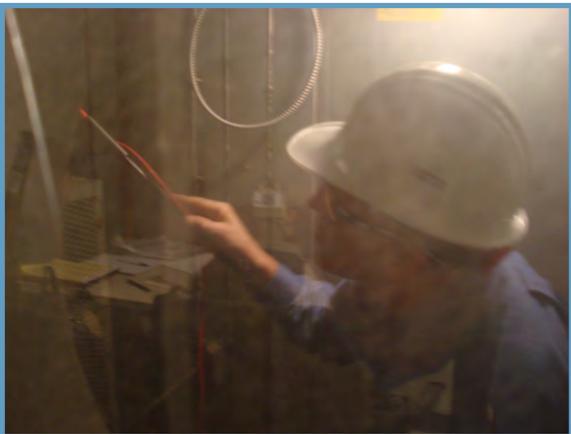
Motor #2 was more difficult to reach because it was located in a tiny room sealed with bulkhead doors to contain noise and rushing air. Pre-installation shaft discharges were measured at 50.8 volts (peak-to-peak).

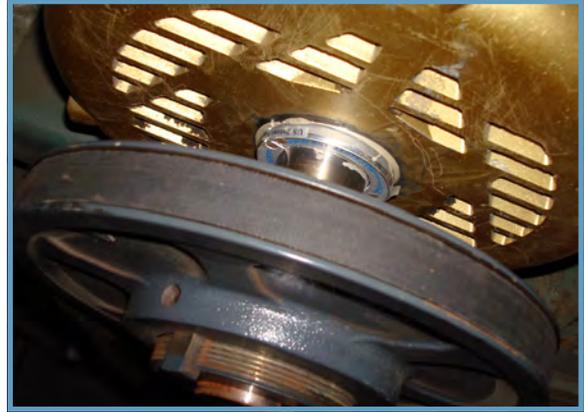
The shaft was cleaned and prepared in the same manner as that used for Motor #1, but because the motor shaft was difficult to reach and only a couple of inches of it between the end bell and a sheave were exposed, the versatility of the split-ring AEGIS® SGR and the ease of installation using conductive epoxy became even more apparent.

A hand-held heater was used to speed the epoxy's cure, and about half an hour after installation the shaft voltage was measured again. This time the reading was only 380 millivolts peak-to-peak.
