Local Motor Shop Helps Kansas Water Authority Solve Bearing-Damage Problem

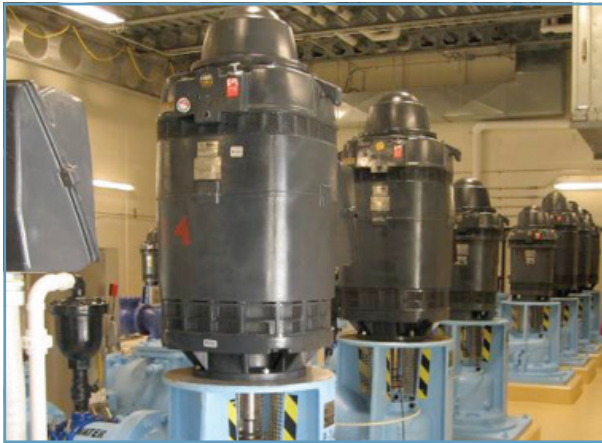
The motors atop these vertical hollow-shaft pumps (at the Reverse Osmosis Water Treatment Center in Hutchinson, Kansas) provide thrust to the pumps' drive ends.

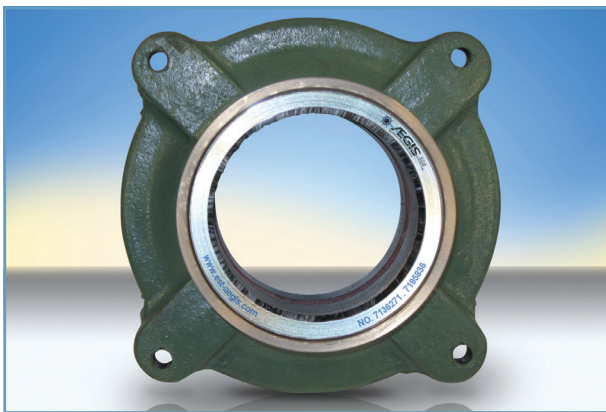
An AEGIS® Bearing Protection Ring mounted in the lower bearing retainer of a vertical pump motor.

IEMCO usually works on motors with failed bearings. After replacing the pitted bearings, his team installs a shaft grounding ring next to the motor's guide (lower) bearing and, using proprietary techniques, applies ceramic insulation to the carrier that holds the thrust (upper) bearing in place at the motor's drive end. For medium-voltage motors, Wilkins uses the larger AEGIS® PRO grounding ring, designed for motor shafts to 30" in diameter.

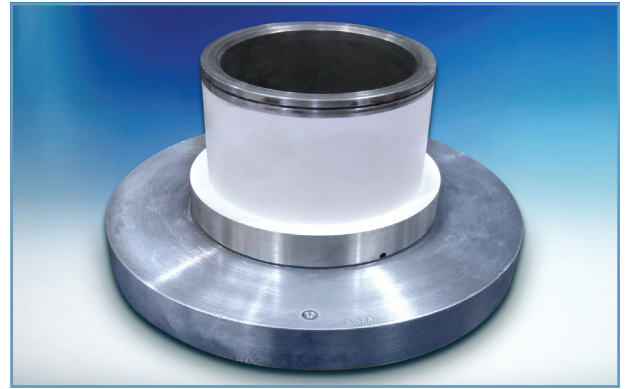
IEMCO coats all vertical pump motor carriers with ceramic insulation, using proprietary techniques.

Some carriers conduct electricity, but Wilkins is convinced that a carrier should be electrically isolated, disconnecting the motor from the pump shaft electrically though not mechanically. In addition to protecting the motor's thrust bearing from electrical damage, this keeps shaft currents from jumping to the bearings of the pump itself, or to the bearings of a gearbox, tachometer, encoder, etc.

To apply the coating of ceramic, IEMCO uses a tightly controlled flame-spray welding procedure. Wilkins' team also grinds each newly coated carrier to very tight tolerances. The finished carrier has a hardness of Rockwell 50C and provides a resistance of more than 1 gigaohm at 1000 volts — far better than the National Electrical Manufacturers Association (NEMA) standard of 1 megaohm at 500 volts.
