Issue 13: Bud's Take on Re-Visit of Excessive Grease

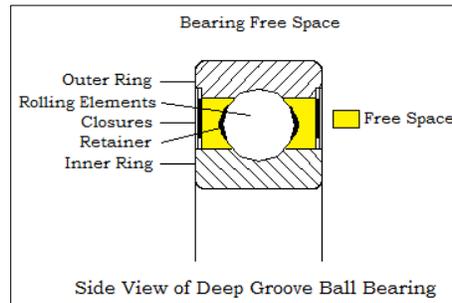
Bearing Free Space is the area remaining inside of the bearing cavity after subtracting the space consumed by the rolling elements and retainer.

Figure 1: Representation of Bearing Free Space

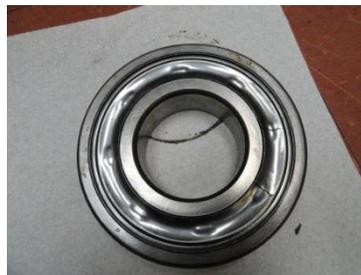
Pic 2: Collapsed shield, possible cause pressure from grease gun.

Bearings with closures on both sides are supplied by bearing manufacturers with approximately 20-50% grease fill. This amount varies by manufacturer and application. These type bearings are considered maintenance free, sealed or shielded for the life of the bearing (or grease.) No grease replenishment is required. One reason closures are employed is due to the grease life exceeding the calculated bearing life. If no grease is added, over-greasing will not occur. Picture 2 shows a collapsed shield that we believe was caused by extreme external pressure from a pneumatic or high pressure grease gun.

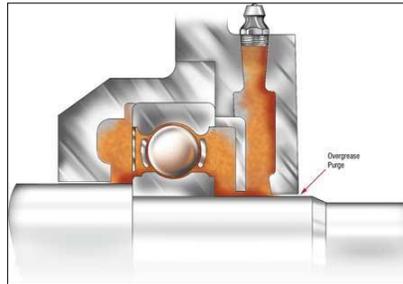
Figure 3: Grease purge.

To focus on excessive or over-greasing we will assume the feeding interval, compatibility, and all other issues are correct. In an application where grease is to be added it is critical that a path is available for excessive grease to leave the chamber. This can be covered with pressure relief valves, drain ports, gaps for allowing purging, see figure 3. If a path is not present, the rolling element will have to work hard to rotate properly resulting in heat buildup.

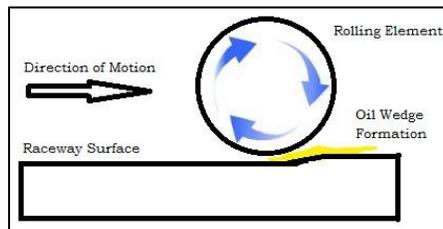
Fig 4: Rolling element rolling over oil

This heat buildup will cause the reduction in bearing clearance, shortening of grease life and lead to premature bearing failure. To simplify the concept of excessive lubrication I use the example of running on a beach. Running in one inch of water requires little work to maintain speed. If the water level is increased to waist high in depth the amount of work required to maintain speed dramatically increases. Figure 4 represents the thin oil film required for proper rotation.
