White Etching Cracks (WEC)

How to reduce WEC in Wind turbines

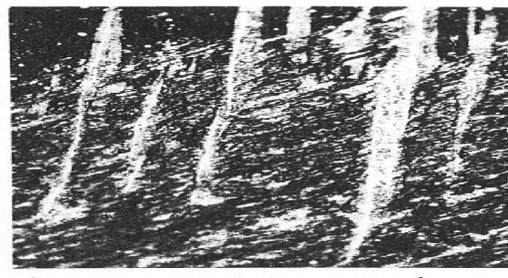
White Bands

Related to classic fatigue

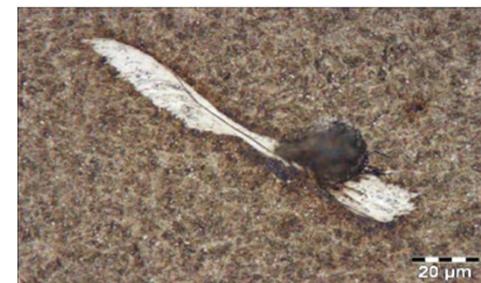
Butterfly

White flanks around non metallic inclusions

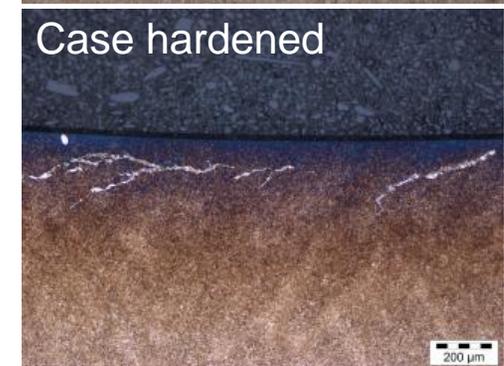
Affected Applications in wind turbines

Rotor shaft
Spherical roller bearings
Tapered Roller bearings

Gearbox
Cylindrical roller bearings
Tapered Roller bearings
in Planet Gears
Intermediate speed shaft
High speed shaft

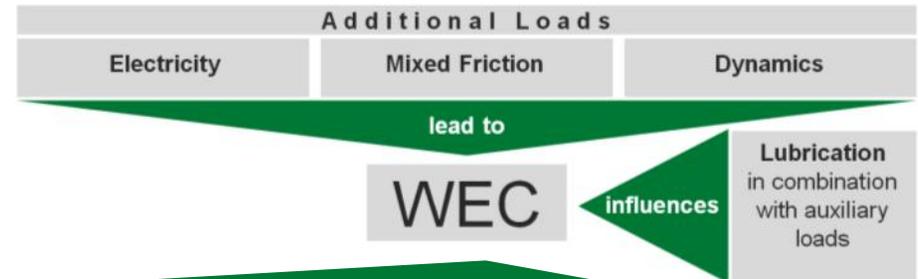
The risk of WEC can be reduced if various points are observed in design of the bearing arrangement and the selection of lubricants and materials.

reduce the risk of

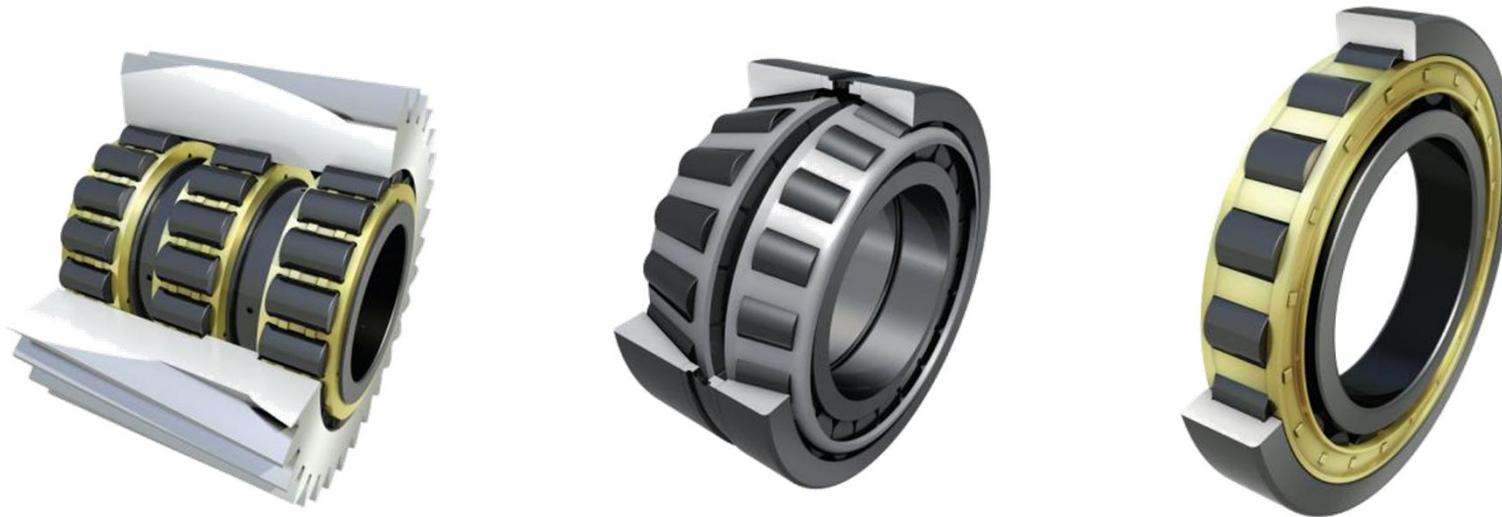
Schaeffler recommends Durotect® B (black oxide coating)

- Good protection against WEC
- **Longest and best field experience: failure rate 0,02%**
482.000 Bearings, < 100 Failures in the past 9 years
- Economical solution
- Durotect® B also minimizes the risk of damage caused by slippage, improves running-in behavior and provides protection against corrosion

What is Durotect® B?

- minimizes the risk of damage caused by slippage
- improves running-in behavior
- provides protection against corrosion
- increases the level of robustness to WEC independent from base material

It has been proven statistically that black oxide finishing of outer and inner rings as well as rollers significantly reduces the formation of white etching cracks.

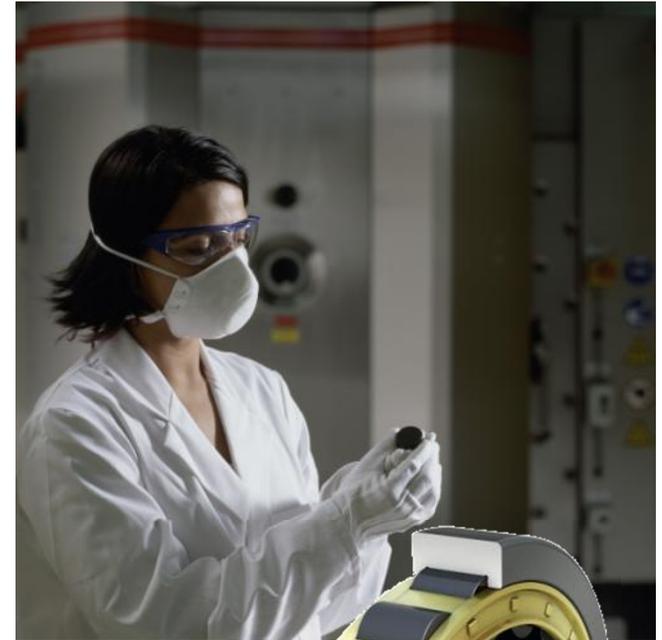
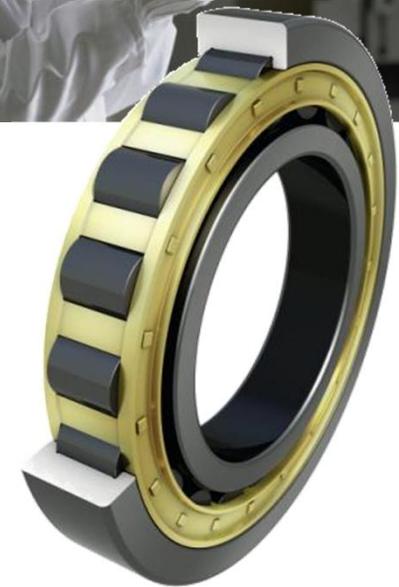
The coating system Durotect® B has been consistently developed from conventional black oxide finishes to give increased performance.

- Coating comprising mixed iron oxides
- Colour: dark brown to deep black
