Case Study: Garlock KLOZURE® Bearing Isolators Keep the Mill Line Flowing at the Steel Mill

Primary Metals - Steel Mill

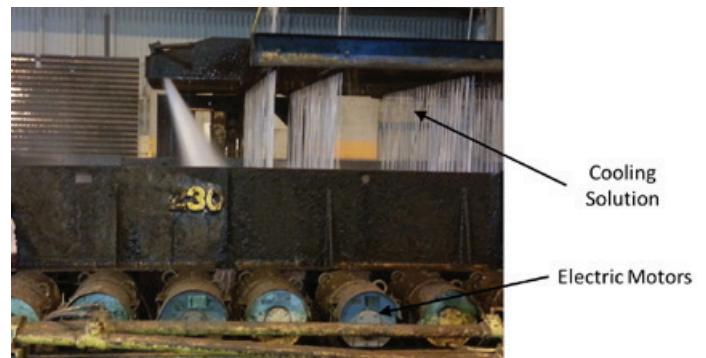
Figure 1: Run-out Table Overview

During the cooling process, power transmission systems are often exposed to airborne contamination and oftentimes corrosive cooling solutions. The power transmission system, in this example, consists of hundreds of rolling elements driven by variable speed electric motors (Figure 1). The electric motors were utilizing standard OEM labyrinth seals, but were failing to provide adequate ingress protection and were failing prematurely due to contamination ingress. The corrosive cooling solutions and slags from the hot steel once entering the bearing chamber will deteriorate the lubrication or attack the bearing directly, resulting in premature bearing failure (Figure 2). This leads to costly repair and downtime of the mill line. Once it was determined that the original equipment labyrinth seals were not providing IP65 or better, a flange mounted GUARDIAN®, IP66 rated bearing isolator was installed on each electric motor. The upgrade of the original equipment labyrinth seal to an IP66 rated bearing isolator solved the problem. It effectively prevents the ingress of the corrosive cooling solutions and any small particles from entering into the bearing chamber. The reliability team was impressed with the results and has decided to upgrade all the seals on the electric motors with GUARDIAN® Bearing Isolators. Once all electric motors were upgraded, the run-out table was no longer a production issue or causing production downtime.

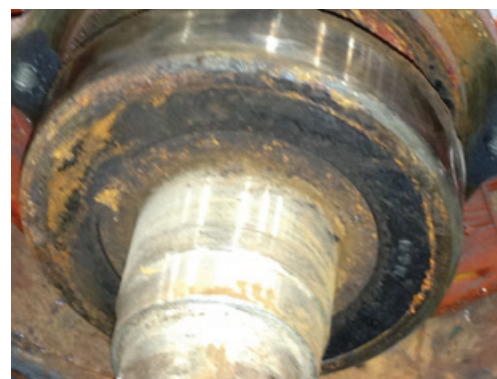
Figure 2: Damaged bearing in the electric motor from ingress of cooling solution
