Issue 7: Bud's Take on Importance of Correct Bearing Selection

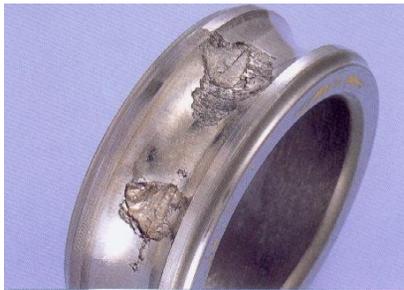
Picture 1. Deep Groove Ball Bearing with flaking

The failure being evaluated is a deep groove ball bearing. You find deep flakes on the inner ring. The flakes are at positions that line up with the ball interval. The flakes appear to have started subsurface so you conclude the damage was caused by severe impact. The root cause could be severe impact from unknown source. If the impact was expected in the application the root cause may be incorrect bearing selection.

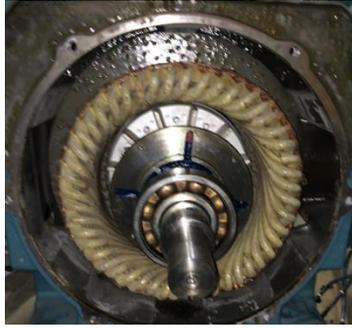
Picture 2. Cylindrical Roller Bearing with skidding

In this scenario we evaluate a cylindrical roller bearing. Skid marks are detected on the inner ring. We are able to rule out contamination, lubrication and fitting. Discussion leads to the fact that the bearing was used in a direct coupled motor application. You conclude that the skidding is a result of the bearing not having required minimum load. A direct coupled application normally does not generate radial load. Without this load the rollers will not be engaged to avoid skidding. The root cause could be the wrong bearing for the application.
