Issue 17: Is Fretting Corrosion a Function of Water or Chemical Attack?

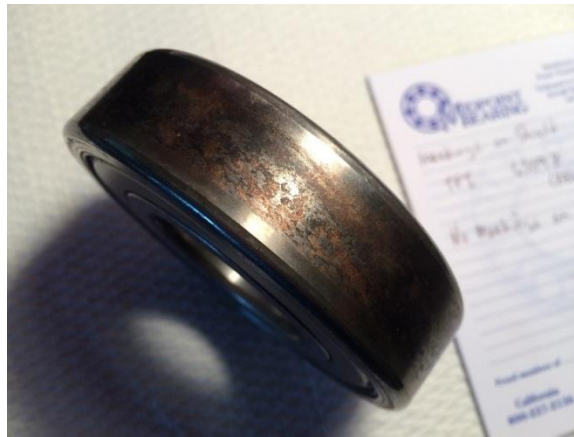
Pic 1: Fretting Corrosion on Outside Diameter

The issue of fretting corrosion occurs between the contacting surfaces of either the journal and bearing bore or the housing and the bearing outside diameter. In general, for bearings, the fitting is based on the rotating ring and how the load is applied. The objective to this fitting guideline is to avoid rapid spinning while allowing a slow creep between the two surfaces. While under load, the motion results in small wear particles that oxidize. The oxidization forms a layer of reddish black corrosion over the interference surface.

Different types of material react differently to this fretting corrosion situation. Most fretting occurs between corrodible steel and case iron fits. Stainless steel and nonferrous metal do fret but do not display the layer of oxidation (reddish black discoloration.)

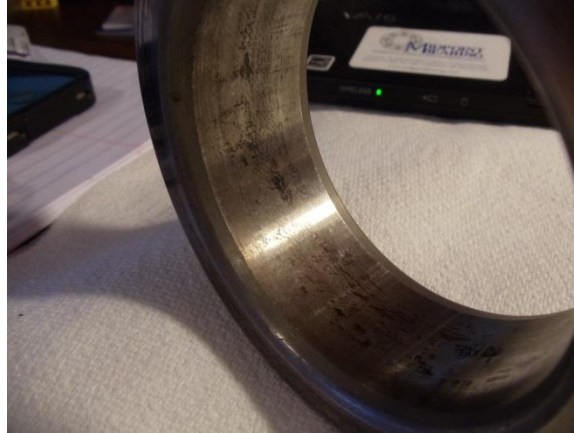
Pic. 2: Fretting Corrosion on Bore.

In most cases, fretting corrosion is not the cause of a catastrophic failure. Studying and paying attention to fretting corrosion patterns can help determine the root cause of a more critical bearing issue. The fretting corrosion pattern can help identify issue such as excessive/loose bearing fits, shaft or housing distortions (tapered shaft or housings, unsupported surfaces) or misalignment. As for preventing, a proper shaft and housing fit will reduce the amount of fretting corrosion to an acceptable level.
