Issue 23: Unique Ball Damage

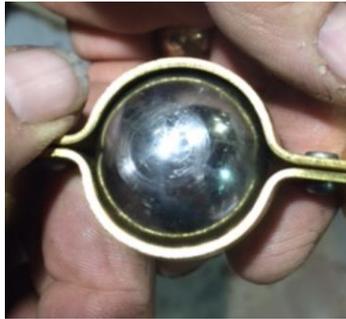
Pic 1: Ball with circular scratches "eyeball"

What could cause the damage seen in picture 1? The damage is caused by the ball contacting the edges of the cage pocket. Normally the scratches will be in multiple directions due to the normal rolling nature of the rolling element. In this case the rolling element was forced to rotate on a single axis so the contact point had very little movement, resulting in the circular scratching. Similar damage can occur when a contaminant is trapped between the cage pocket and the rolling element. There are multiple root causes: improper fitting, heavy load, improper lubrication, and so on. Banded ball damage is often found 90° from the circular scratching.

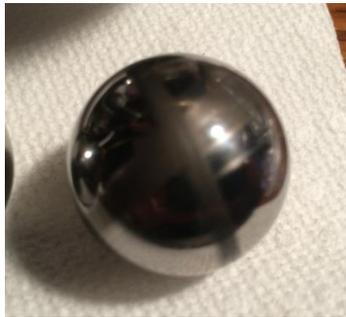
Pic 2: Ball with bands crossing "X marks the spot"

What is the cause of the “X” marking on the ball shown in picture 2? When a ball stops gyroscopically spinning and rotates on one axis the banded ball damage can occur. This failure has two separate bands; this can happen if a shutdown or cooling occurs after the first band is formed. The same issue occurs again making another band, just pure luck to make a nicely formed X. Similar to the previous failure, there can be multiple root causes to this failure including: improper fitting, heavy load, improper lubrication.

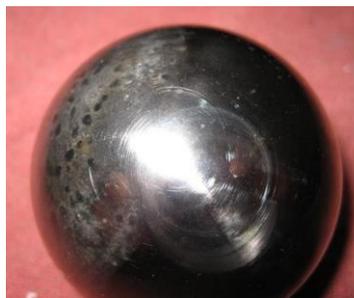
Pic 3: Ball with leopard spots and eyeball.

What caused the Midpoint Bearing coined “Leopard Spots” ball? The pattern is caused by corrosion or chemical contamination while the bearing was not in operation. Contamination in the lubrication caused the rust/corrosion damage. The eyeball or circular scratches occurred the same way as previously mentioned. In this case it is possible that the contamination in the lubrication is the cause of the rolling elements to rotate on a single axis.
