# White Etching Cracks (WEC)

How to reduce WEC in Wind turbines

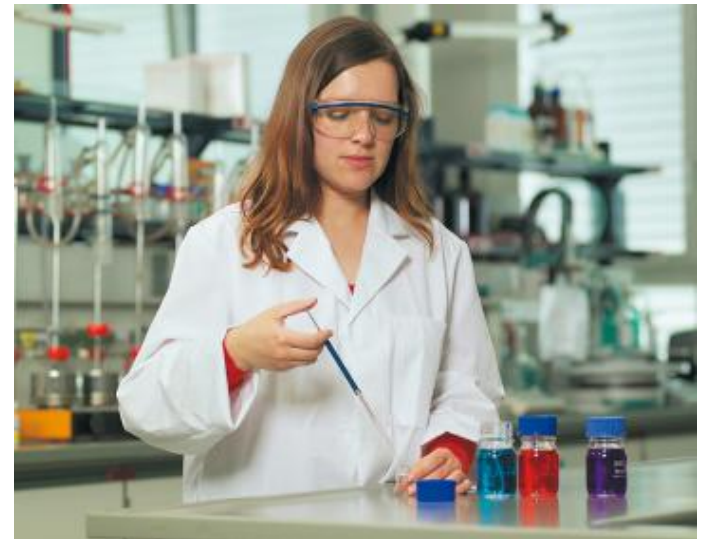
### White Etching Cracks (WEC)

Crack networks including white etching flanks

A type of White Etching Area WEA

→ Nital etching: phase that do not corrode, appear white

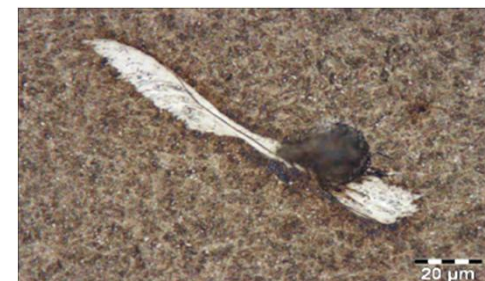
### Butterfly

White flanks around non metallic inclusions

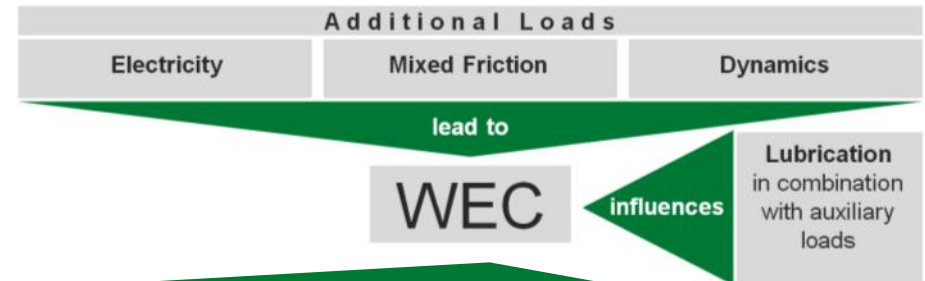
The risk of WEC can be reduced if various points are observed in design of the bearing arrangement and the selection of lubricants and materials.

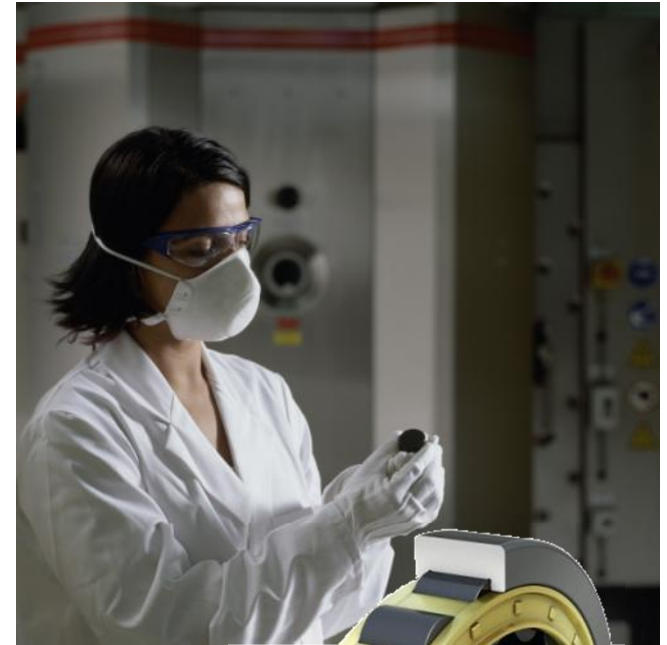
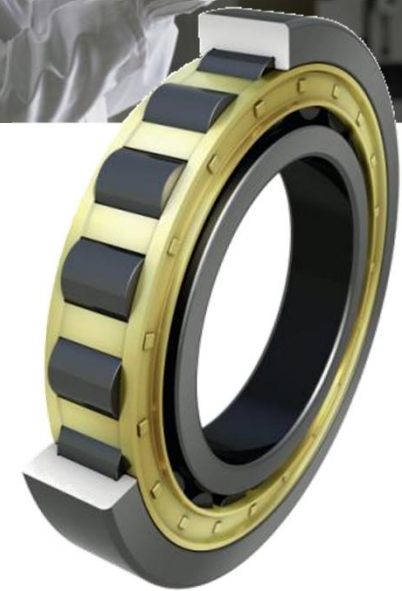
- Coating comprising mixed iron oxides
- Colour: dark brown to deep black

Schaeffler's Surface Technology Competence Center has developed an ideal coating system to reduce/eliminate WEC damage.

- minimizes the risk of damage caused by slippage
- improves running-in behavior
- provides protection against corrosion
- increases the level of robustness to WEC independent from base material
