Issue 23: Bud's Take on Unique Ball Damage

Unique Ball Damage

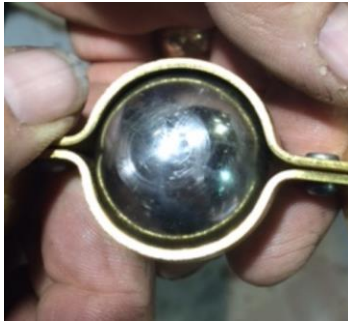
Pic 1: Ball with circular scratches "eyeball"

Circular Scratches or “Eyeball” on Ball

What could cause the damage seen in picture 1? The damage is caused by the ball contacting the edges of the cage pocket. Normally the scratches will be in multiple directions due to the normal rolling nature of the rolling element. In this case the rolling element was forced to rotate on a single axis so the contact point had very little movement, resulting in the circular scratching. Similar damage can occur when a contaminant is trapped between the cage pocket and the rolling element. There are multiple root causes: improper fitting, heavy load, improper lubrication, and so on. Banded ball damage is often found 90° from the circular scratching.

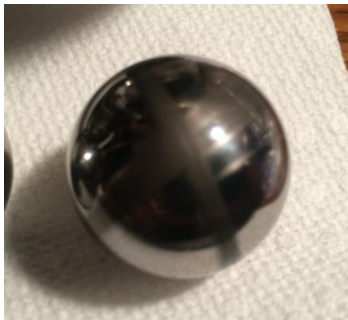
Pic 2: Ball with bands crossing "X marks the spot"

X Marks the Spot

What is the cause of the “X” marking on the ball shown in picture 2? When a ball stops gyroscopically spinning and rotates on one axis the banded ball damage can occur. This failure has two separate bands; this can happen if a shutdown or cooling occurs after the first band is formed. The same issue occurs again making another band, just pure luck to make a nicely formed X. Similar to the previous failure, there can be multiple root causes to this failure including: improper fitting, heavy load, improper lubrication.

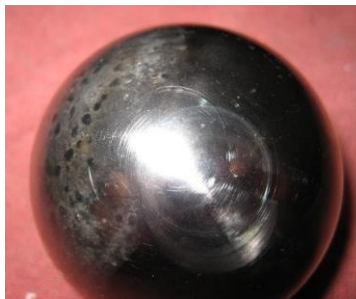
Pic 3: Ball with leopard spots and eyeball.

Leopard Spots

What caused the Midpoint Bearing coined “Leopard Spots” ball? The pattern is caused by corrosion or chemical contamination while the bearing was not in operation. Contamination in the lubrication caused the rust/corrosion damage. The eyeball or circular scratches occurred the same way as previously mentioned. In this case it is possible that the contamination in the lubrication is the cause of the rolling elements to rotate on a single axis.
